9th INTERNATIONAL CONFERENCE ON CONCRETE  
UNDER SEVERE CONDITIONS-ENVIRONMENT & LOADING

## *Permeability and condition of concrete in the Argentine Antarctic ‘Carlini’ Base*

A condition assessment of several concrete buildings located in the Argentine Antarctic ‘Carlini’ Base was conducted. It consisted in a visual inspection of the main structural elements, detection of pathologies, *in situ* measurement of the coefficient of air-permeability  $kT$  and of the carbonation depth. This paper describes the scope of the investigation and the main results obtained. The main pathologies detected were: construction defects, shallow cover depths, freeze-thaw damages and chloride-induced steel corrosion. The  $kT$  values were in the “High” to “Very high” range for 3 out of the 4 buildings investigated and “Moderate” to “Low” for the other building. Based on the information collected, a prognosis of the durability of the buildings is attempted as well as recommendations for future constructions in the extreme Antarctic climate.

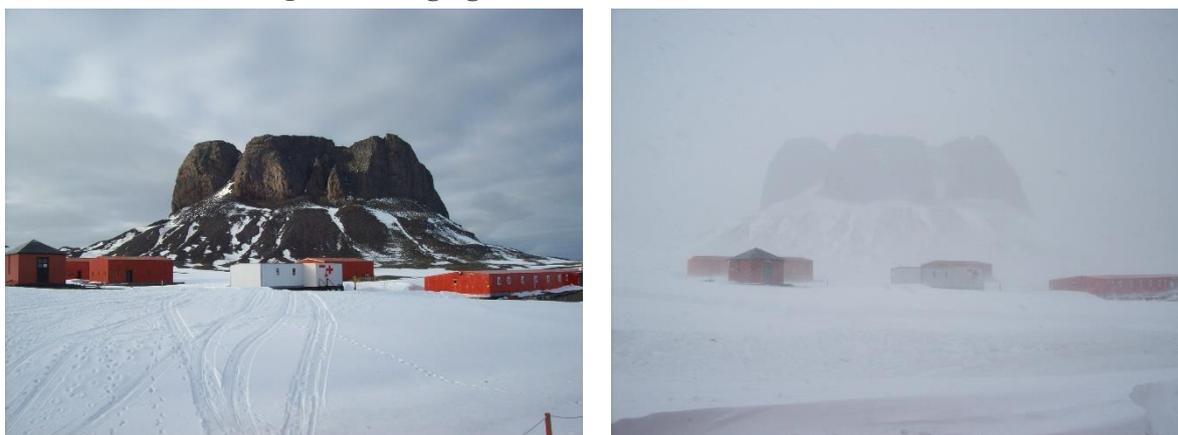
Fig. 3 – Changing climatic conditions at ‘Carlini’ Base

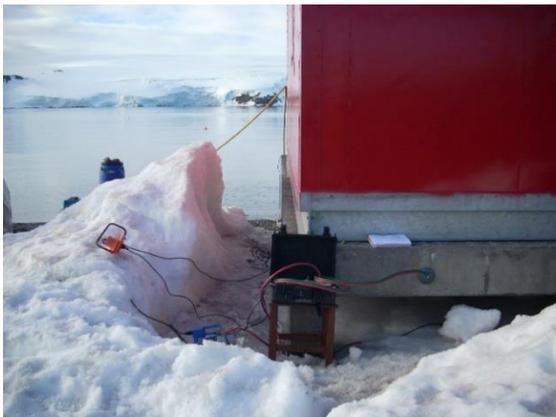
**Fig. 5 – Test on uncoated vertical surface**

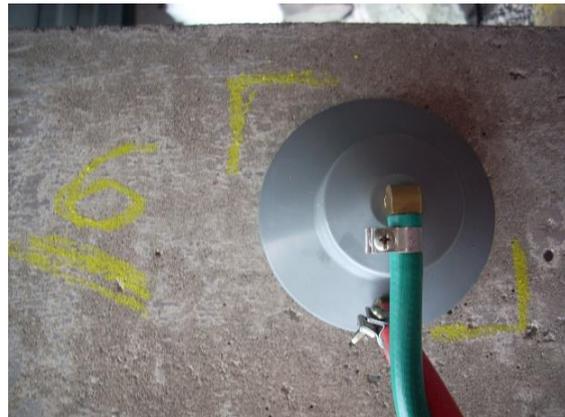
**Fig. 6 – Aspect of uncoated surface under test**

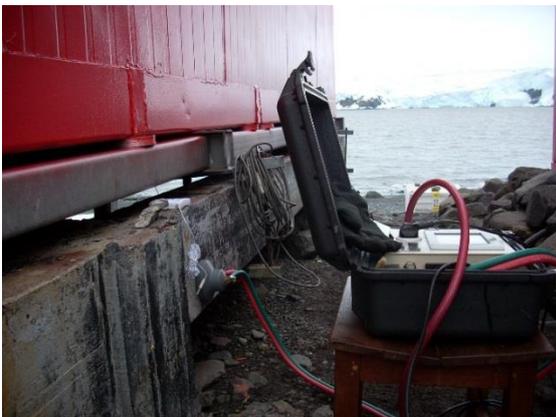
**Fig. 7 – Test on vertical coated surface**

Another problem found was that some of the concrete surfaces were covered by a coating, asphaltic in the case of MH and DL buildings and latex in the case of CB, with tests made on areas with and without coating.

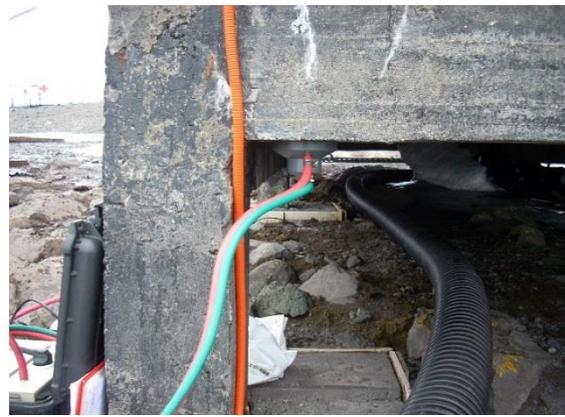
**Fig. 8 – Test on underside of concrete beam**

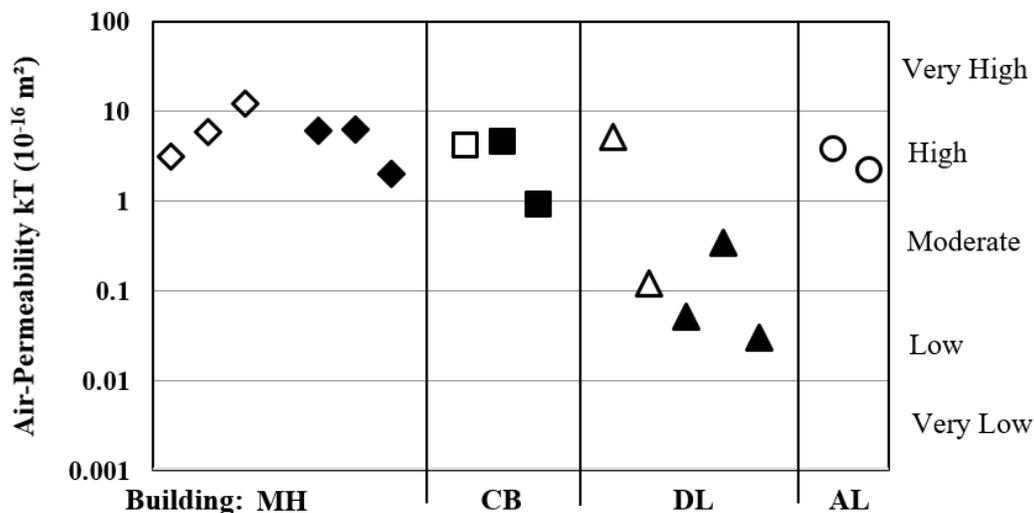
Fig. 9 – Results of coefficient of air-permeability obtained on four buildings of ‘Carlini’ Base

A summary of the results of the coefficient of air-permeability  $kT$ , obtained on the four buildings is presented in Fig. 9 (each point represents the geometric mean of data obtained on the same element). The black symbols refer to tests made on coated surfaces, whilst the white ones on uncoated surfaces. The qualitative scale, shown at the right-hand side of the chart, indicates the ‘Permeability Classes’, updated and extended from those originally proposed in [9].

The first conclusion that can be drawn from the results in Fig. 9 is that the coatings of the concrete surfaces seem to have little or no effect on the measured value of  $kT$ .

The other important conclusion is that buildings MH, CB, AL present air-permeabilities within the ‘High Permeability’ range, whilst DL building results fall within the ‘Moderate/Low Permeability’ ranges (i.e. one to two orders of magnitude lower  $kT$  values).

The significantly better concrete quality displayed by the DL building, revealed by its lower permeability, can be attributed to better mix design and concrete practices, possibly attributed to a previous planning of the building’s construction.

Based on the Exp-Ref model [10], the service life of a reinforced concrete structure subjected to chloride-induced corrosion is inversely proportional to  $\sqrt[3]{kT}$ . Hence, for the same cover thickness, the service life of the DL concrete structure can be expected to last  $\sqrt[3]{10} - \sqrt[3]{100}$  (~ 2 to 4.5) times more than that of the other buildings.

- Define an expected service life, to be used in the design
- Structural design, specifications and construction should involve well-trained personnel
- Concrete mixes should comply with the requirements and include air-entrainment
- Equipment should be adequate for cold weather concreting conditions
- Fixing of steel must leave sufficient room between bars and ensure a generous cover thickness
- The feasibility of using precast construction elements, manufactured in mainland and shipped and assembled on site, should be seriously considered
