“Evaluating the long-term effectiveness
of a permeable formwork liner ”

Roberto Torrent

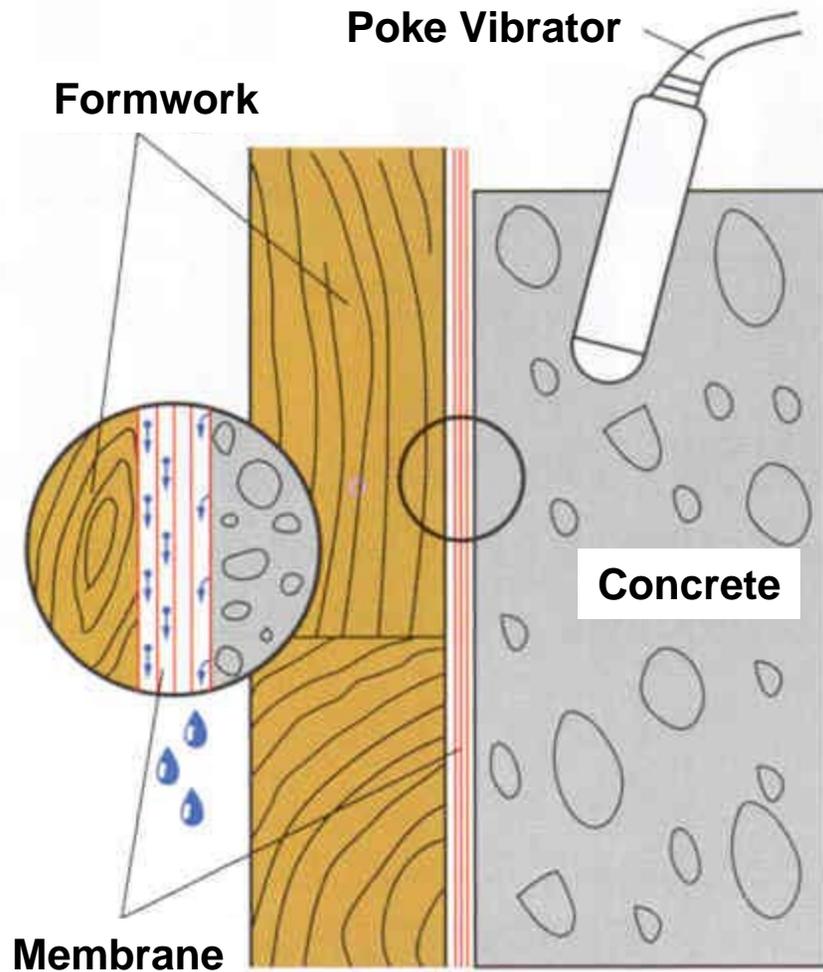
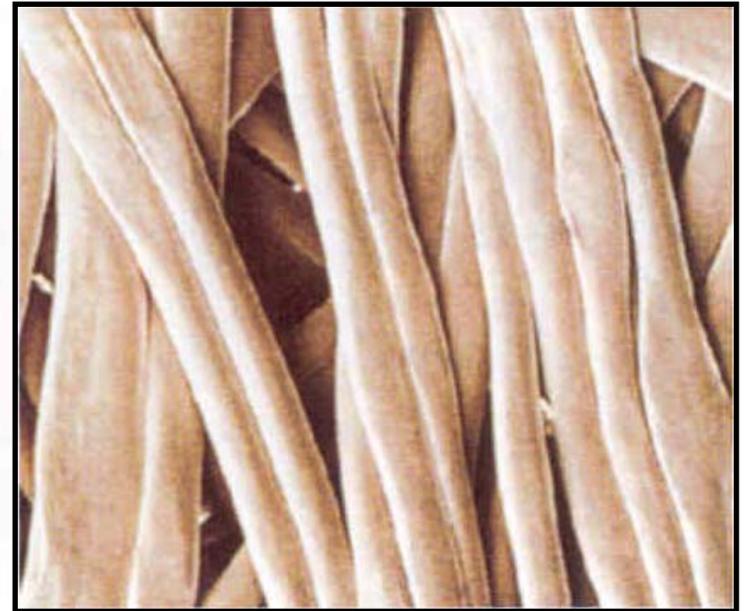
**Magnified view of the fabric of
"Zemdrain" Permeable
Membrane**

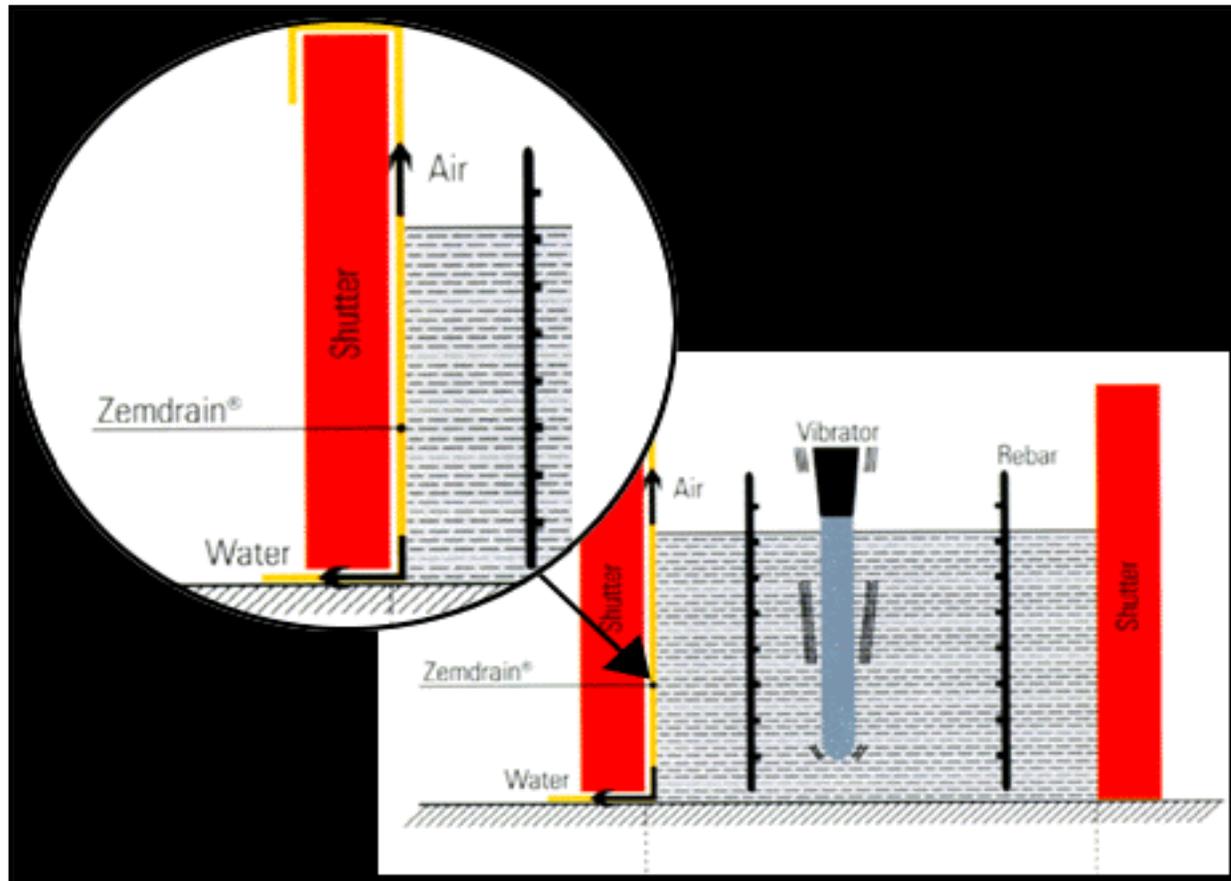
The water and the air in the concrete are expelled during vibration and are drained after traversing the membrane, which retains the cement and fine particles.

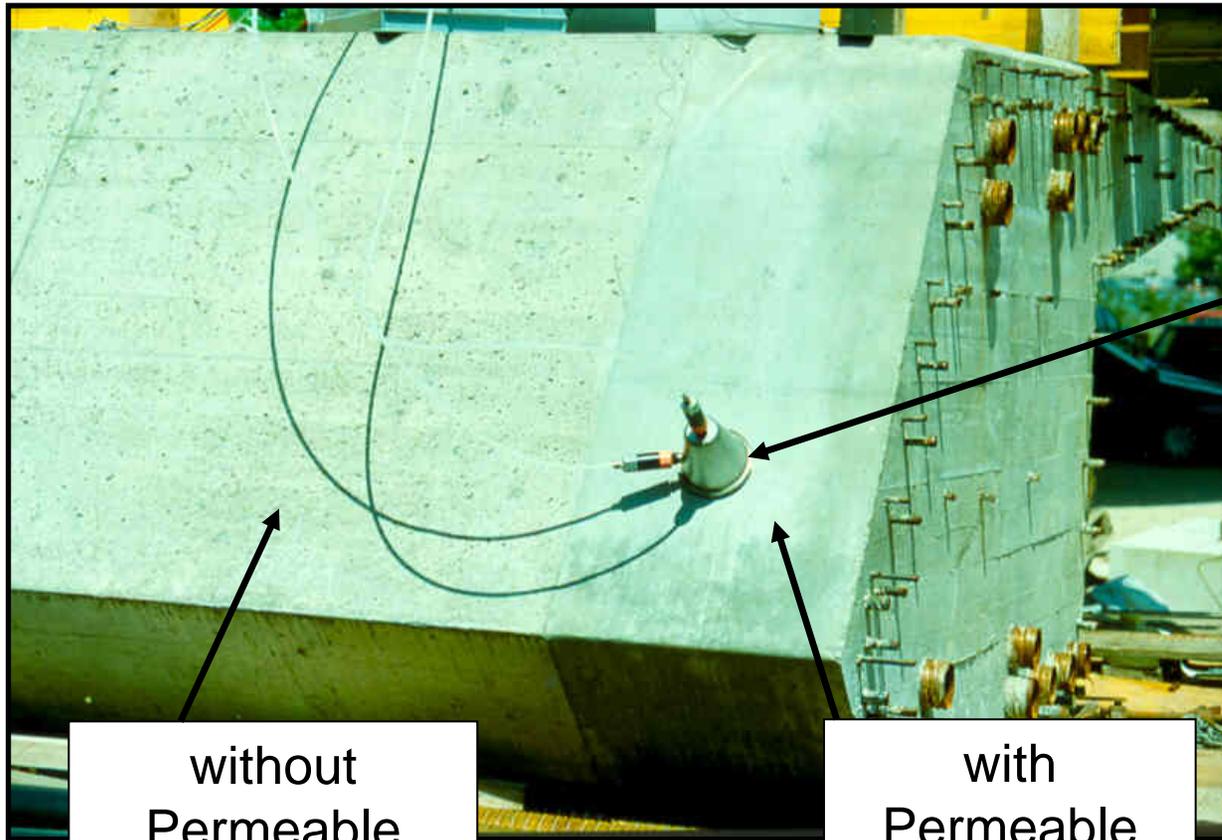
without
Permeable
Membrane

with
Permeable
Membrane

A visual indication of the effect of the membrane is the absence of air bubbles and the darker shade of gray on its surface, indicating that both air and water were drained through the liner.

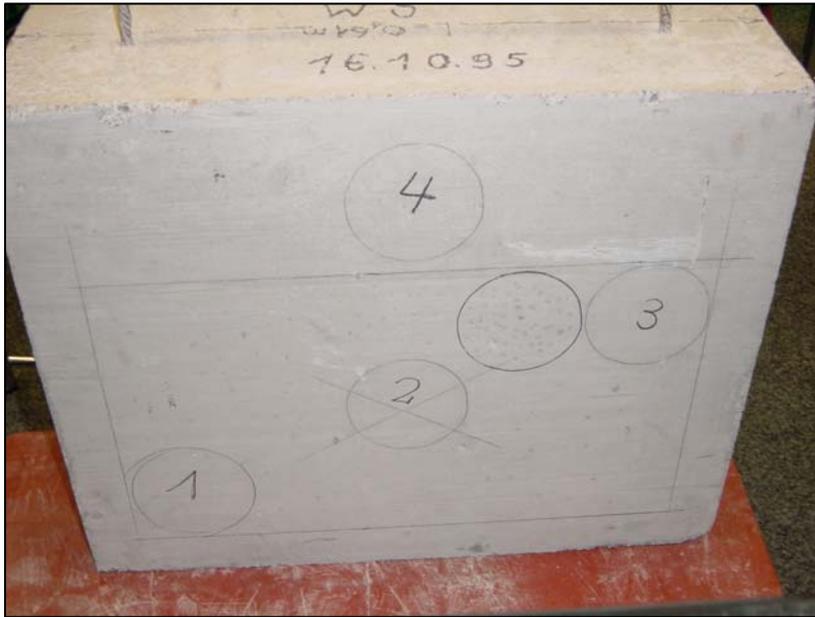
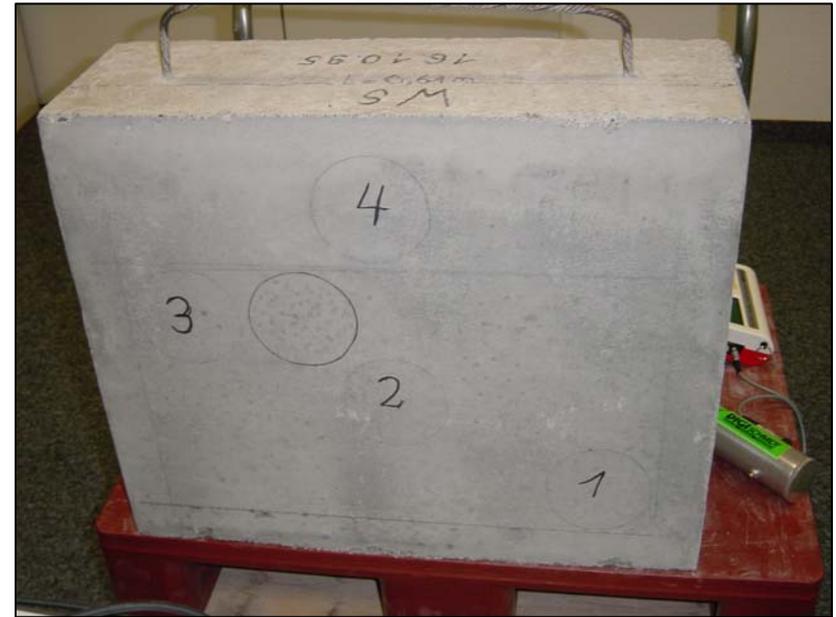
Test Panel – View of both surfaces

Natural Surface

„Zemdrain“ Surface

Same as in the previous picture, the “Zemdrain” surface of the Panel had almost no air-bubbles and was darker, except a fringe at the top where not enough hydraulic head existed to force the water through the membrane.

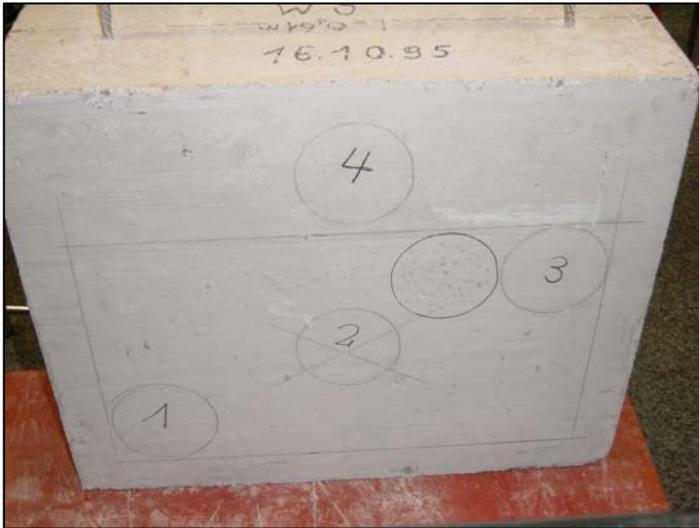
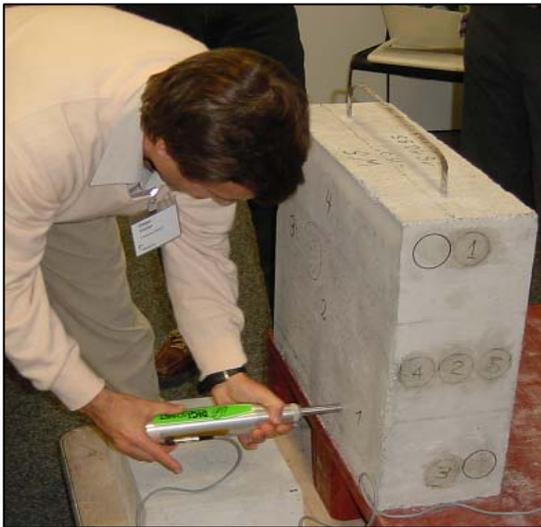
Test Panel – Rebound and kT

The coefficient of air-permeability kT was measured (applying the Permea-**T** \odot *RR*) on the circles 1, 2 and 3 to assess the effect of “Zemdrain” on the potential durability.

The Rebound was measured (applying the Digi-Schmidt hammer) on evenly distributed points, to assess the effect of “Zemdrain” on the surface (probably deeply carbonated at that age and storage conditions) hardness.

Only the dark area visibly affected by “Zemdrain” was investigated on both sides.

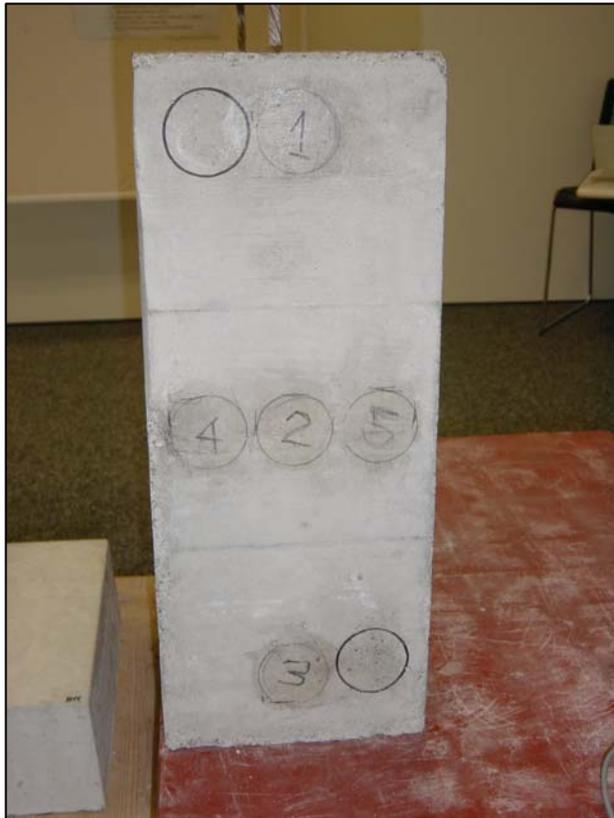
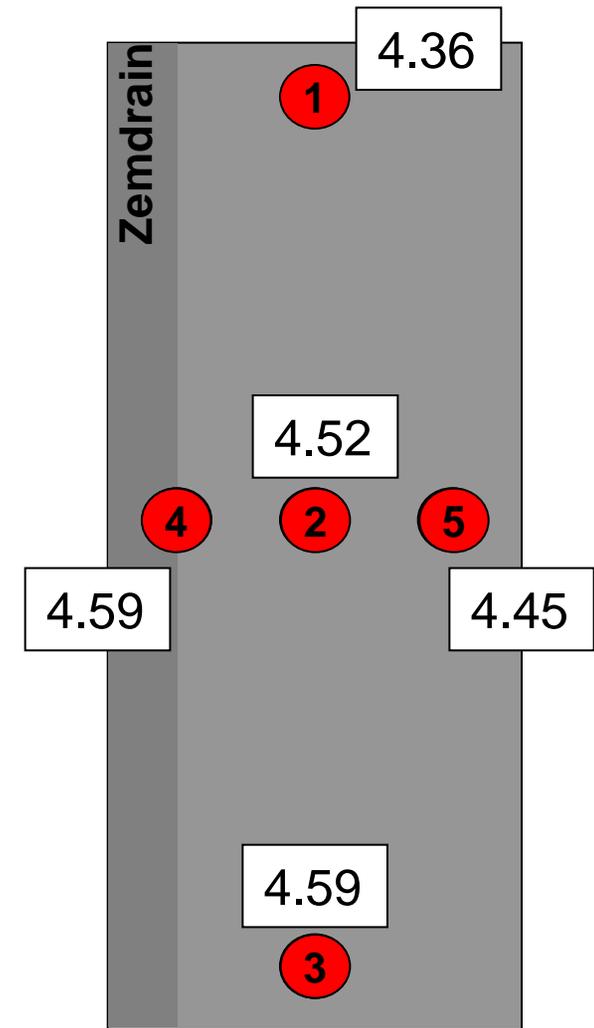
Test Panel – Applied NDT Tests

The Ultrasound Pulse Velocity (applying the PUNDIT) was measured along the length of the Panel, on the 5 locations shown in the picture. The values of UPV (km/s) obtained are shown in the sketch.

The well known effect of significantly better quality at the bottom of the element, compared with the top, can be clearly appreciated.

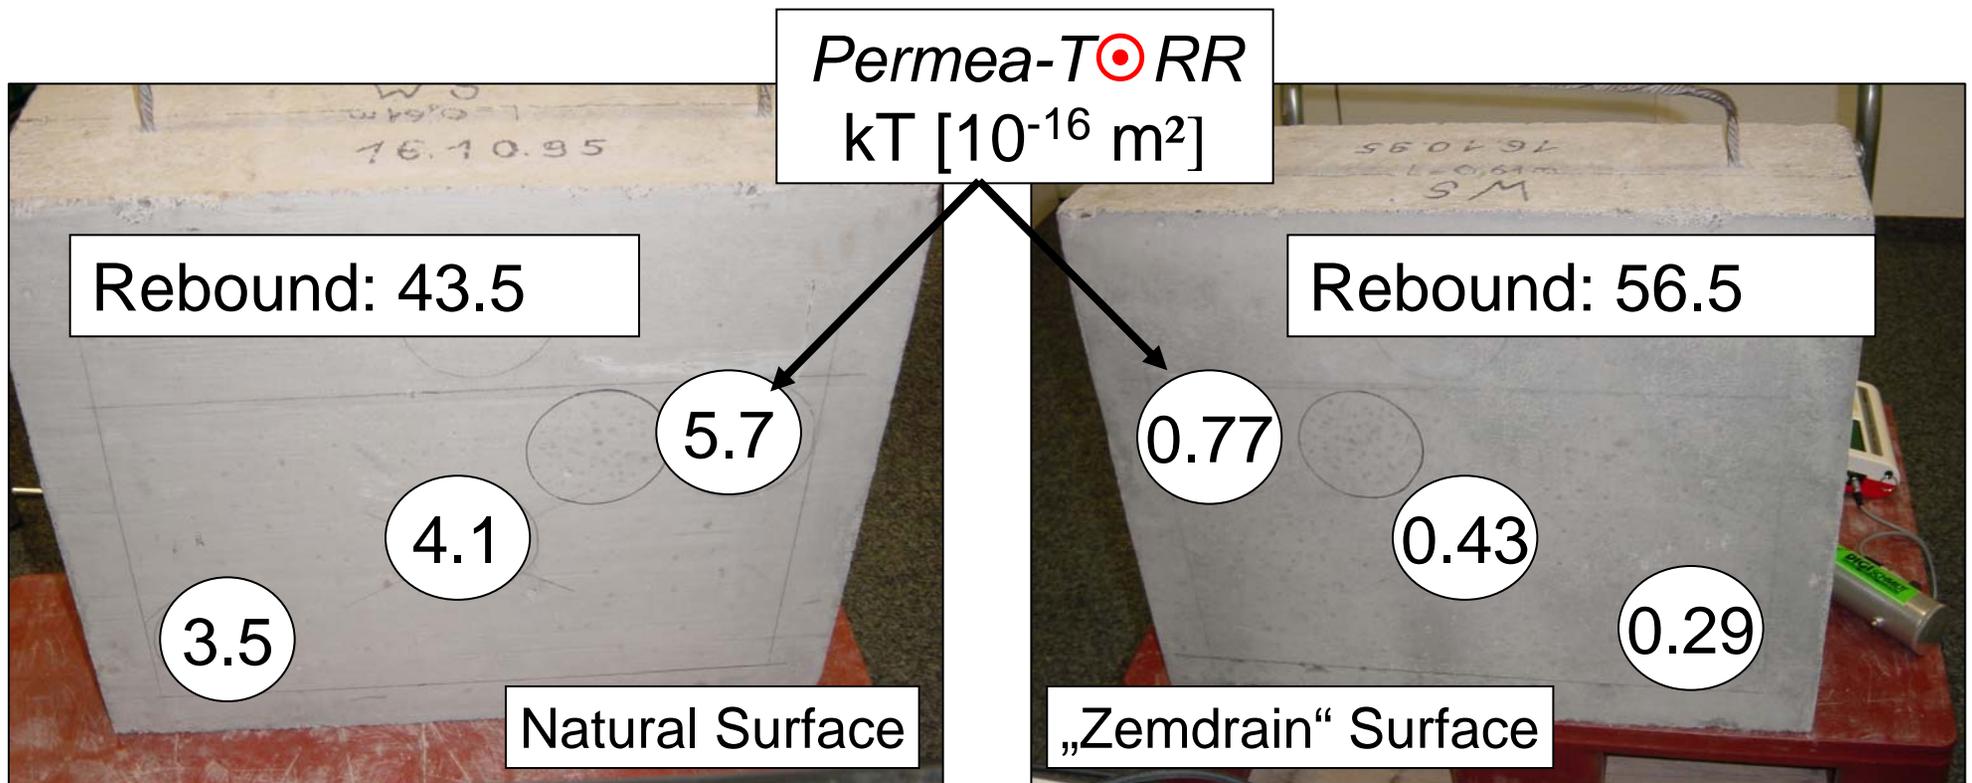
Test Panel – Results of Rebound and kT

The “Zemdrain” face shows a Rebound number 30% higher and a coefficient of air-permeability almost 10 times lower than the Natural surface, thus confirming the long-term beneficial effect of the liner on the hardness and “penetrability” (and hence durability) of the surface layers of the panel.
